SEWAGE DISPOSAL SYSTEM REPAIR PLAN
 FOR PROPERTY KNOWN
 as 15 WOLF ISLAND ROAD in
ROCHESTER, MA
 PREPARED FOR
LINDEN 35, LLC

SHEET 1 OF 2 SHEETS

SCALE: 1"=20' DATE: NOVEMBER 13, 2018

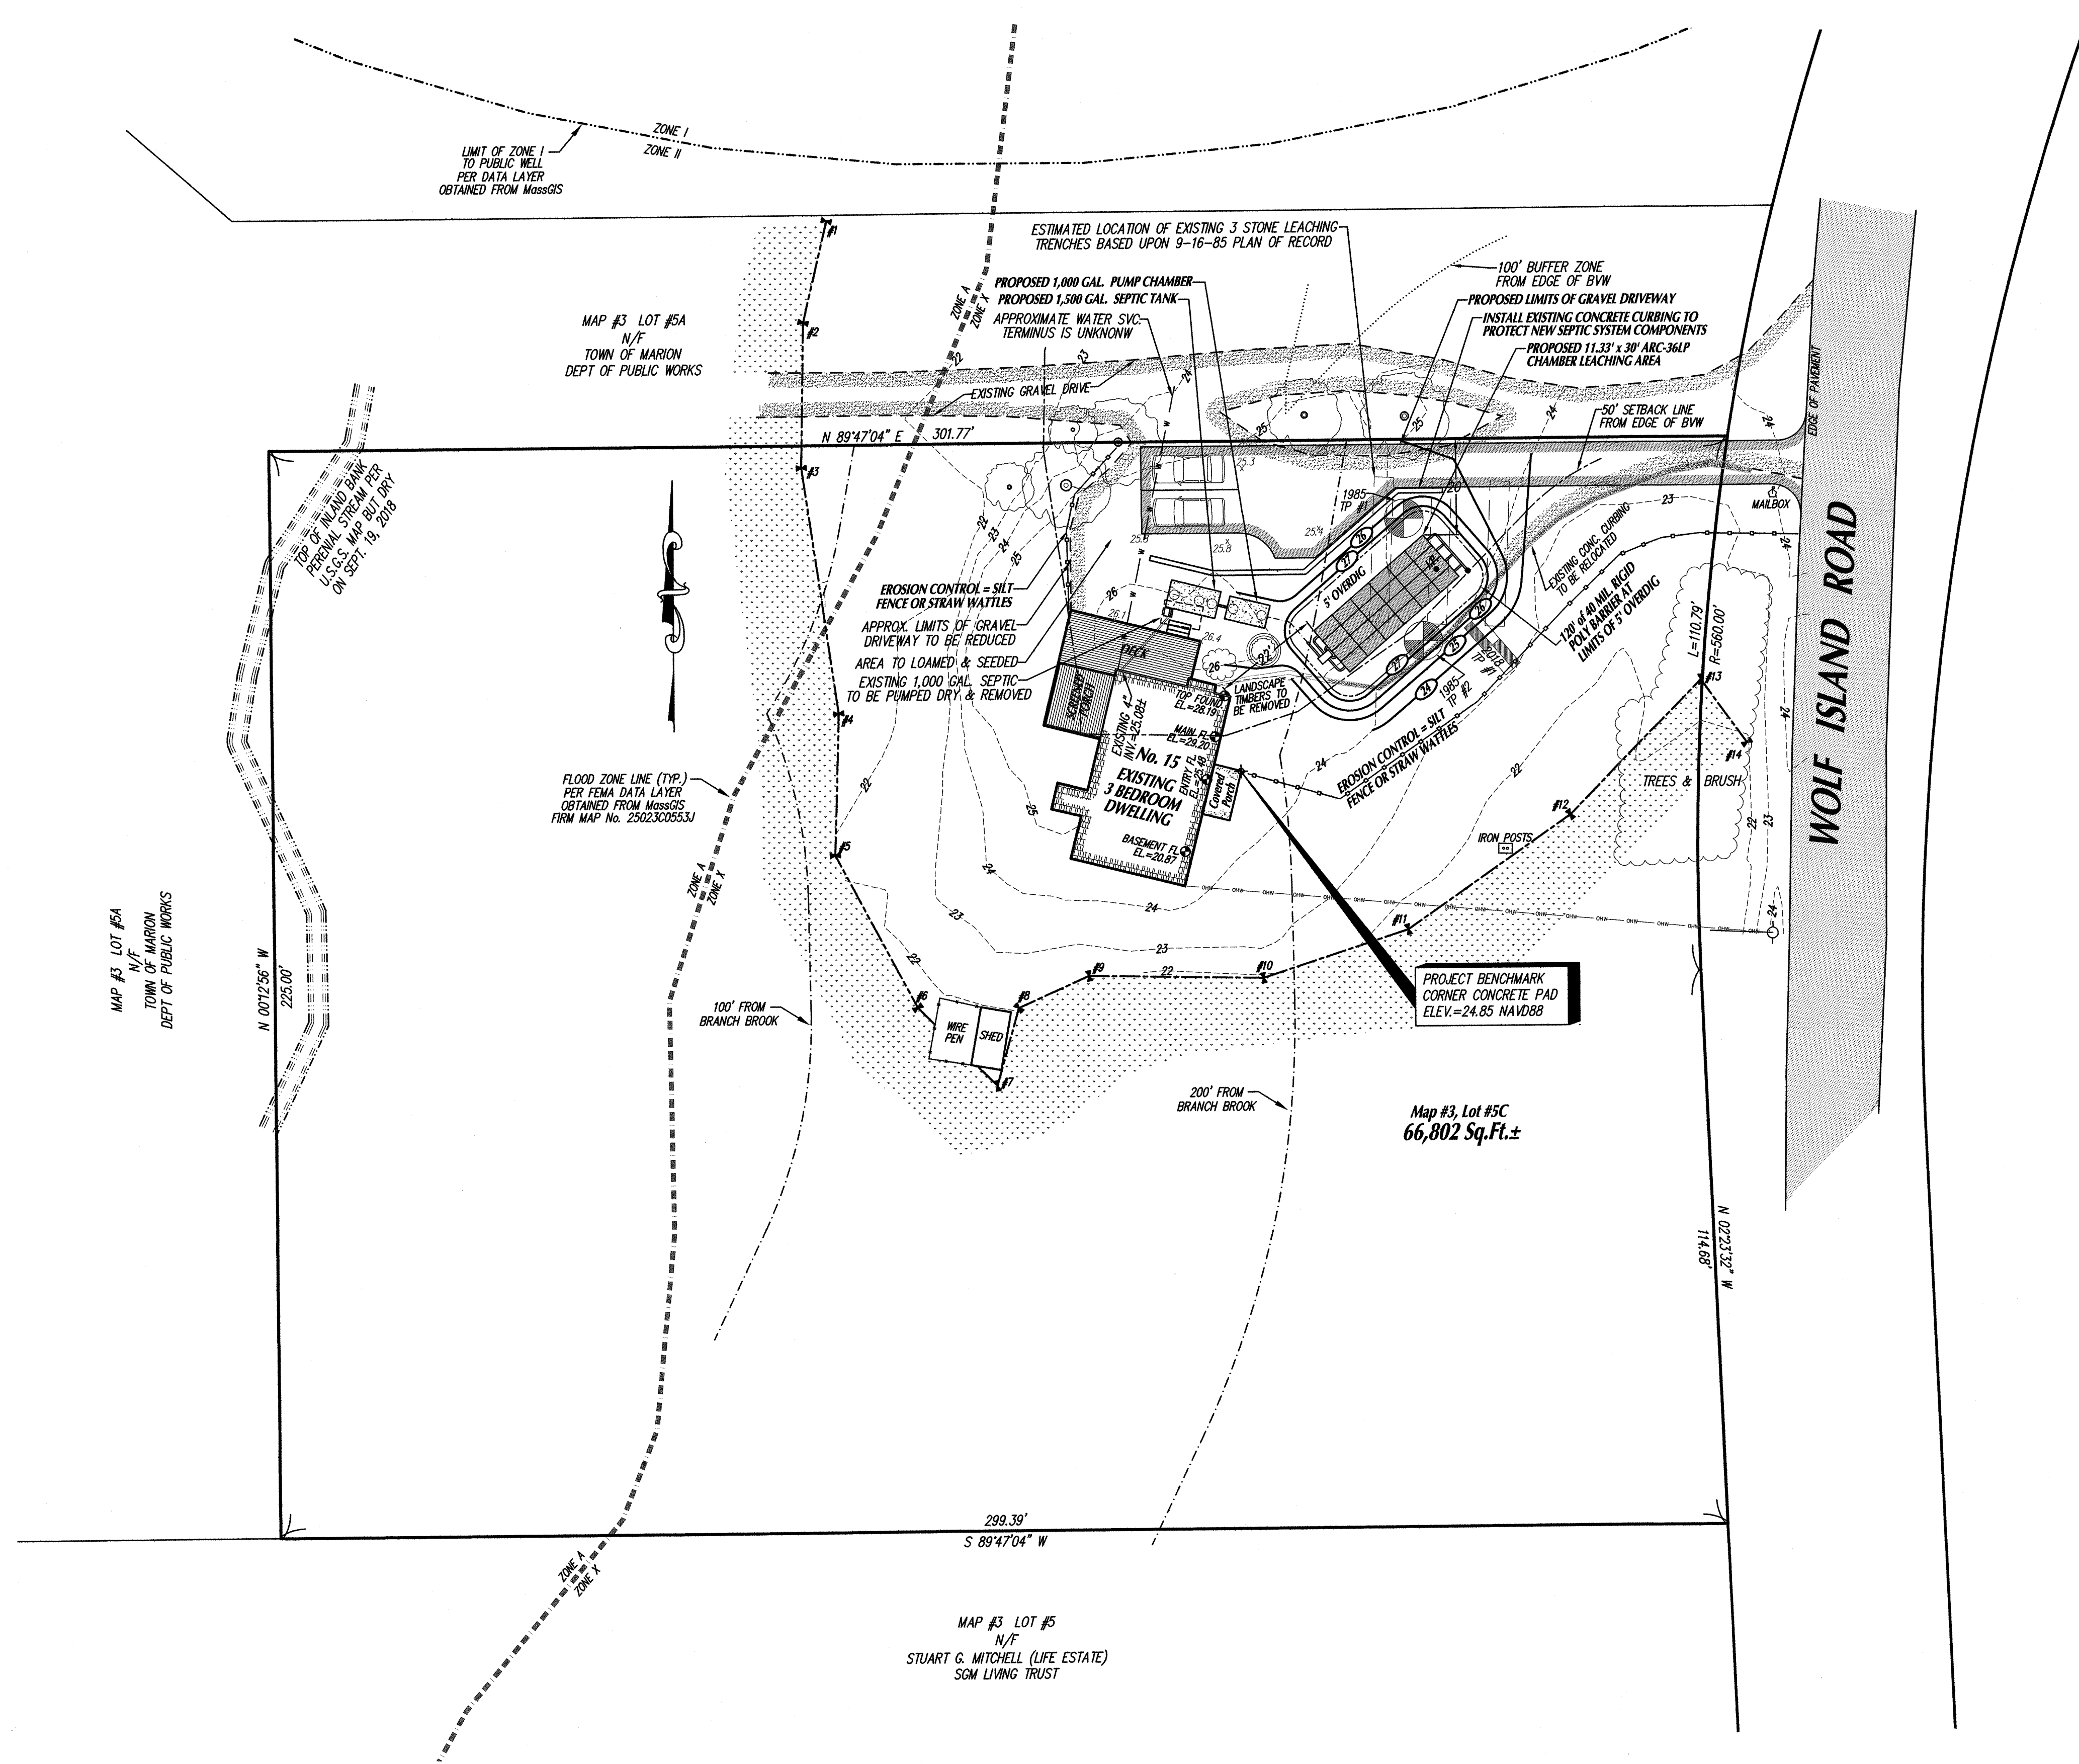
- TITLE 5 REQUESTED VARIANCES:**
- 1.) 310 CMR 15.212, DEPTH TO GROUNDWATER; LEACHING AREA SEPARATION FROM MAXIMUM HIGH GROUND WATER, REQUESTING A 4 FT. SEPARATION VS. THE 5 FT. MIN. REQUIREMENT
 - 2.) 310 CMR 15.211, MINIMUM SETBACK DISTANCES; SEPTIC TANK SEPARATION FROM A WATER SERVICE LINE, REQUESTING A 7± FT. SEPARATION VS. THE 10 FT. MIN. REQUIREMENT
